Cyclone Marcia – February 2015

Cyclone Marcia (Marcia) formed on 18th February 2015 and intensified rapidly, crossing the coast near Shoalwater Bay, Qld. as a rare Category 5 cyclone. (USA Cat.4). Marcia remained a category 3 far inland on 20th February and after several hours of heavy rainfall, intensities increased with around 250mm of rain in 3 hours over the western slopes of the Calliope Range (*Official report*).

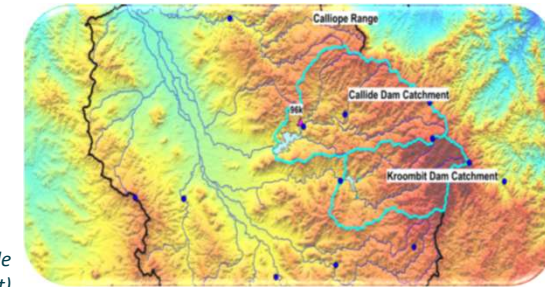
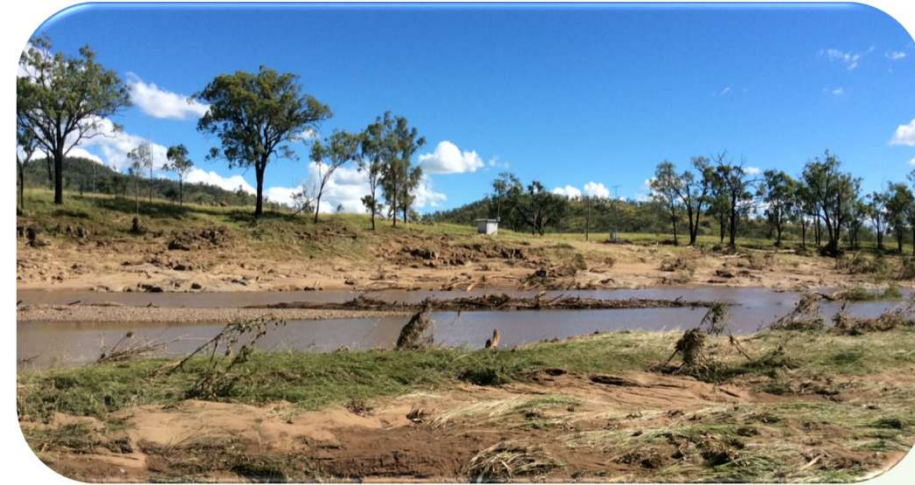
Catchment map and Callide creek post event (J Stuart)
