Oroville Spillway Failures – February 2017

In February 2017, heavy rainfall in the Feather River basin led to outflows through Oroville Dam. Spillway slab failure occurred resulting in erosion and damage. Gated releases ceased for damage assessments and the lake level was allowed to rise over the emergency spillway crest, which in turn also experienced significant erosion.

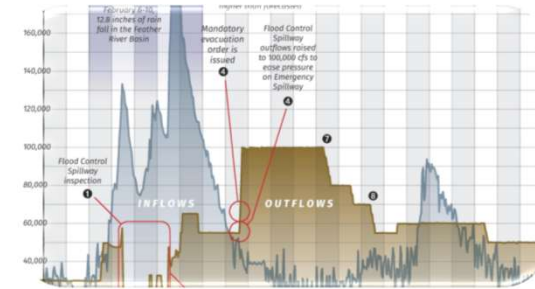
Review graphic and failed spillway (Source: Chico Enterprise-Record)
