South Burnett Flood Event Report Overview

Summary of December 30th Kingaroy Flood

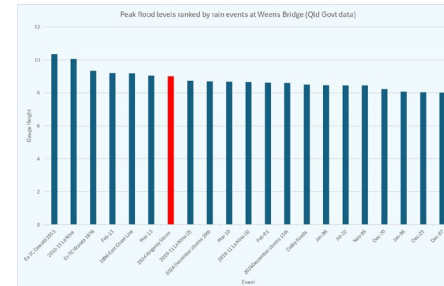
Figure R1: Peak flood levels ranked by rain events at the Stuart River gauging station at Weens Bridge. (DLGWW)

In the broader region, critical infrastructure impacts occurred in both the Barker Creek, and Stuart River catchments with roads and bridges inundated. Analysis of historical peaks from the Qld Govt. gauging station at Weens Bridge, shows a significant rate of rise with the change in water level advancing from 0.8m below the bridge deck to inundation within 20 minutes, and with a time of closure of over 24 hours. The location saw the highest discharge since 2013.

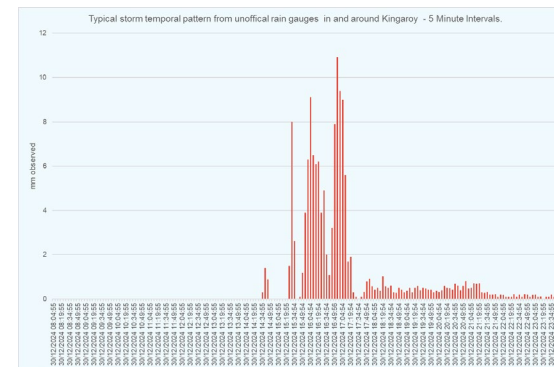
Figure I1: Typical storm intensity of 5-minute data from unofficial rain data

Assessment of the intensity data sourced from 20 informal gauges confirms two periods of very intense rainfall, observed at Kingaroy AWS, occurred across a much larger area. The two periods are clearly visible in Figure I1, a typical temporal pattern from Kingaroy.
